12. Miller's Wagon

Meadcroft of Welwyn et. al., Miller's wagon, circa 1880

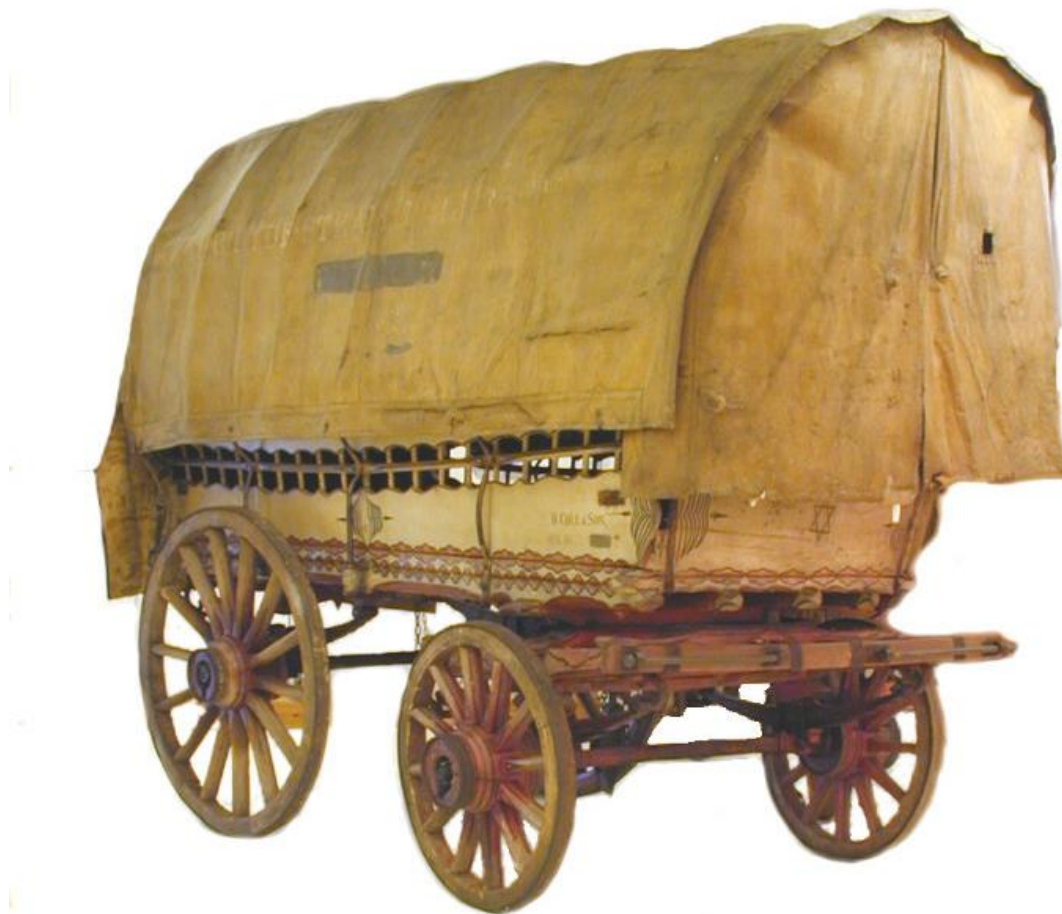
The wagon, much as it is today. It can be seen in the Museum's Wagon Walk gallery (MERL 51/1295)

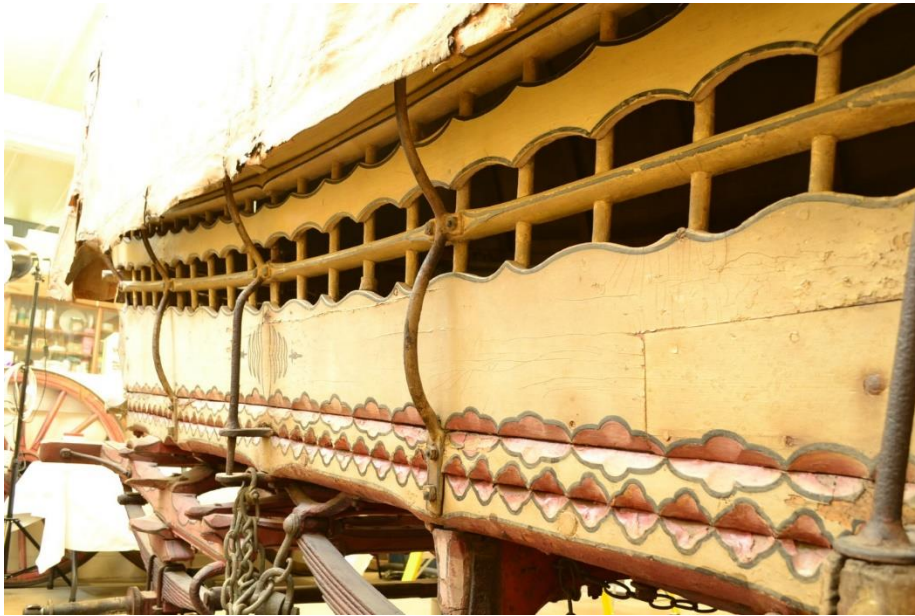
Detailed image taken during conservation showing the side panels and iron straps, and the relatively light construction of the vehicle (MERL 51/1295).

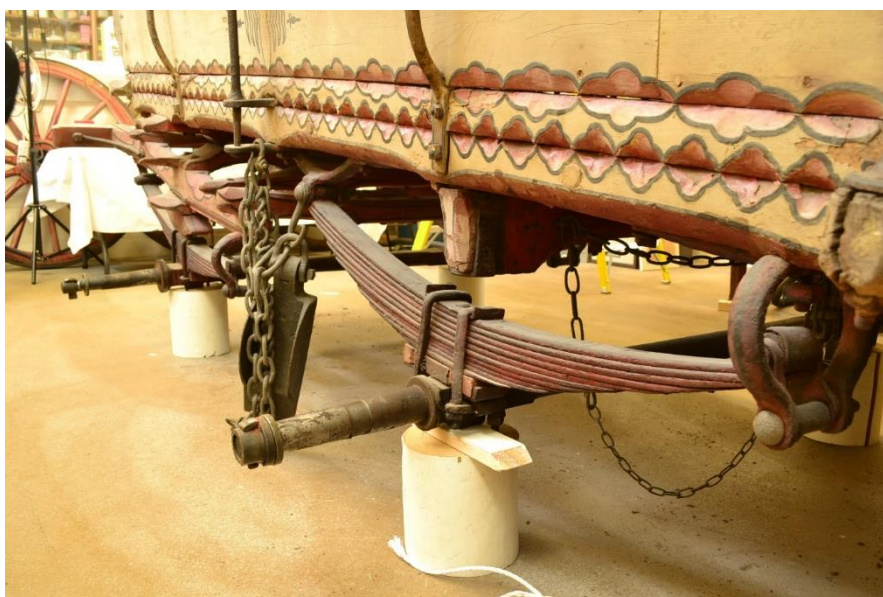
Detailed conservation image showing decorated side panel, springs, and rear axle. Note the strap on timber above the spring; this acts as a stop to limit travel and thus prevent breakage of springs (MERL 51/1295).

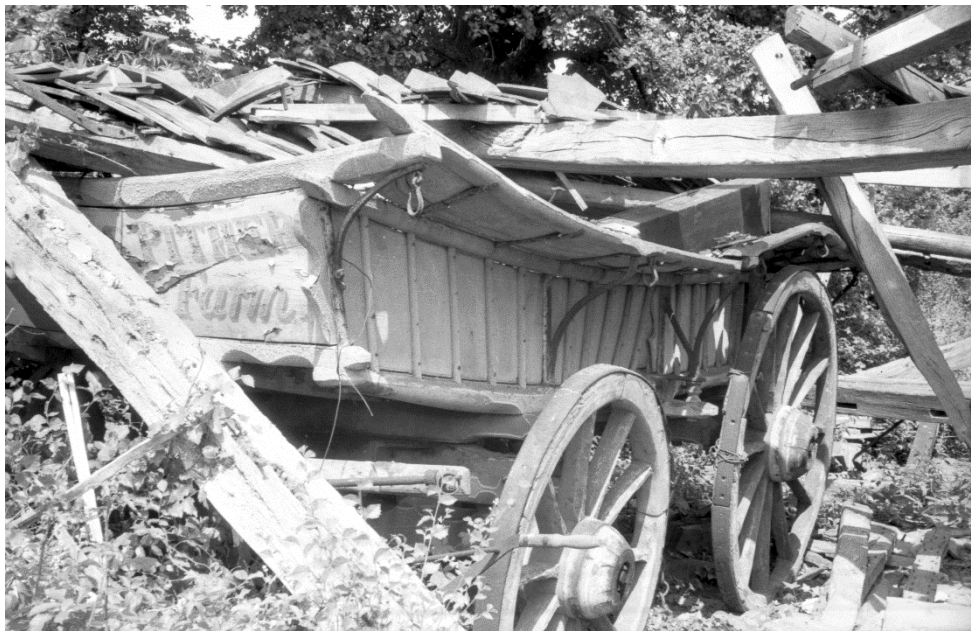
This mid-twentieth century photograph shows a different wagon that has been left for scrap. It shows how lucky we are that the miller’s wagon had been so well-cared for (MERL 35/4522).

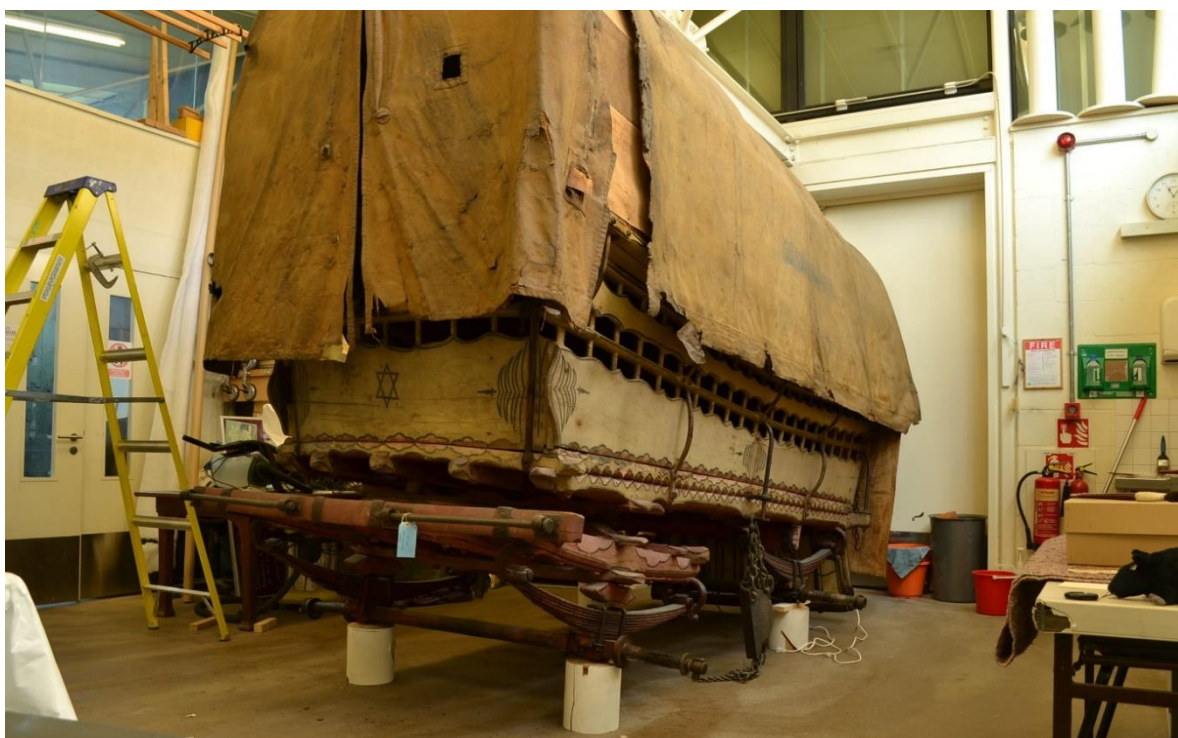
The wagon, wheels temporarily removed, to lower it to fit in the conservation studio (MERL 51/1295).

As part of The MERL's *Our Country Lives* redevelopment and redisplay project (2013-2016), the miller's wagon was brought into the conservation studio for much-needed treatment. This was a mixture of good news and bad news. The canvas tilt and the wheels were particular causes for concern. To bring the very tall wagon into the studio, all four wheels had to be removed. A great discovery was the date stamp and the maker's name on the axle: 'Stenning // Euston Road // 1876'. Many accidents were caused by inferior axles and axle stubs, resulting in legislation for manufacturers of axles to stamp them with a date and makers name.

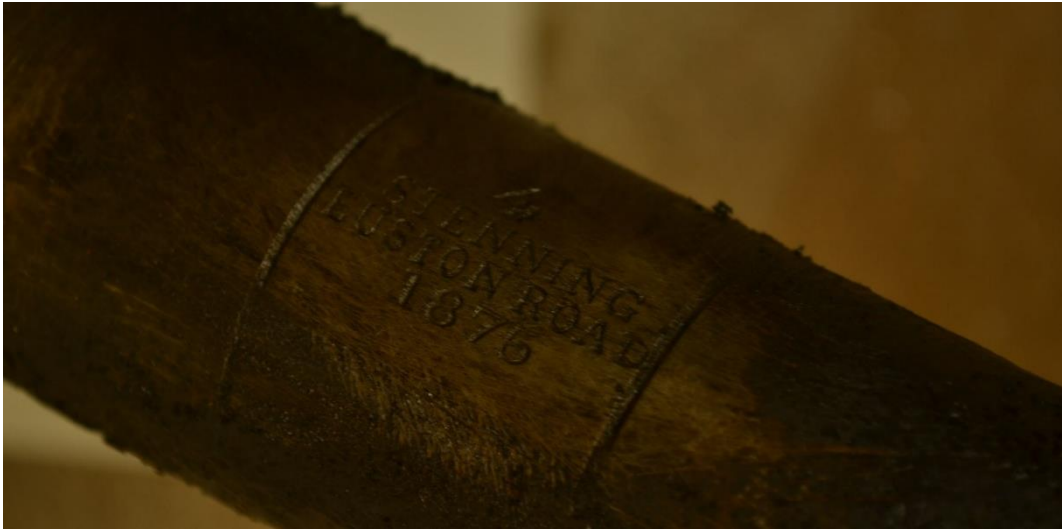
Good news: careful inspection when the wheels were temporarily removed revealed a maker's name and address and a date of manufacture stamped on the axle. (MERL 51/1295).

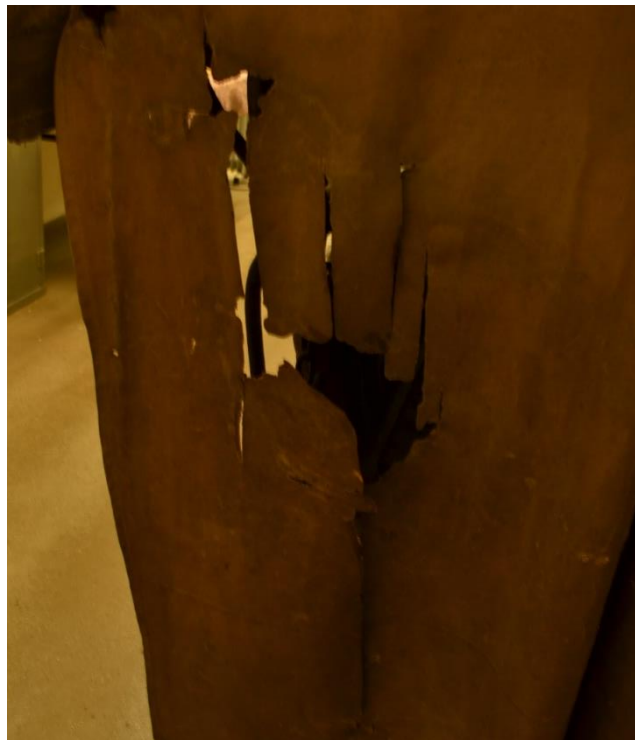
Bad news: a full assessment showed some damage, such as this tear to the canvas tilt, which needed careful and considered conservation (MERL 51/1295).

The *Copydex* repairs on the tilt had started to fail and the weight of the canvas resulted in many tears. The old, heavy hessian repair patches were all removed and replaced with thin calico. Ph-neutral PVA was used to adhere calico to canvas, and the repairs were again colour-matched using acrylic paint.

Left: repairs to tears in the canvas tilt underway, using calico and a Perspex clamping system. Right: canvas tilt repairs completed and colour-matched ready for redisplay (MERL 51/1295).

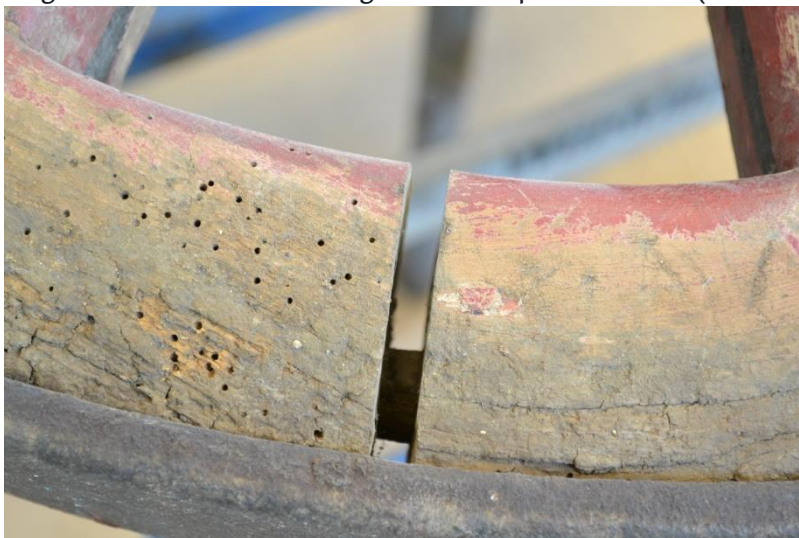
As a whole, The MERL wagon holdings had suffered from severe fluctuations in humidity, leading to loose joints in the woodwork, especially the wheels. As the wheels carry the weight, it is essential that they remain as strong as originally intended. On careful inspection it was found that the miller's wagon had suffered similarly. The shrinkage gaps were covered with brown polymer clay. The wheel was placed (clay-covered side down) on trestles and the gaps filled with a clear casting epoxy resin. Once filled, the wheel was turned over again and the clay removed. The fill was colour-matched with acrylic paint. Though not easily reversible, this method gives strength and stability, whilst retaining all the original materials.

A typical shrinkage gap between felloes of the wheels, also showing old insect damage (MERL 51/1295).
